MICROSTRUCTURAL IMPROVEMENTS OF SAC ALLOYS WITH BI ADDITIONS DURING ACCELERATED THERMAL CYCLING

Eva Kosiba[1], Polina Snugovsky[2], John McMahon[2], Doug Perovic[3]
[1]Zebra Technologies, [2]Celestica, [3]University of Toronto
Mississauga ON, Canada

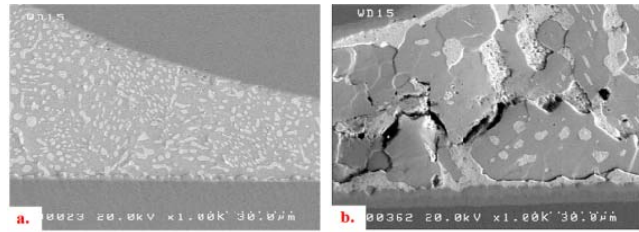
Figure 3: SnPb solder a) before testing and b) after 3000 cycles -55°C to 125°C**[12]**

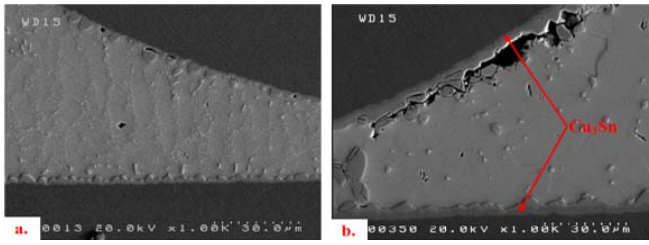
Figure 4 shows a solder attach made up of SAC305 a) before testing and b) after 3000 cycles of harsh testing. From Figure 4a) we can see the dendritic arms of the βSn appear relatively small and evenly spaced with small dispersiods of Ag_3Sn in the interdendritic spacing. After ATC, the Ag_3Sn particles appear to have coalesced into fewer, larger particles. Additionally, the IMC layers formed between the lead and solder as well as between the solder and copper pad have increased in size and appear to have two phases, Cu_3Sn and Cu_6Sn5 as seen in Figure 4b). A Cu_3Sn layer was not detectable at zero time. Finally, the dendritic structure does not appear to be well defined after thermal cycling. Polarized light or electron backscatter diffraction (EBSD) is needed to properly view the grain structure. Figure 5 shows an example of a BGA solder joint that failed during thermal cycling; recrystallized grains appear in the region where high shear strength is experienced, and where the final crack propagated. Using EBSD, it has been proposed that this recrystallization occurs ahead of the propagating crack.[10] Fractures can easily propagate along the regions created under creep conditions, notably between grain boundaries and along the bulk solder/IMC interface.

Figure 4: SAC305 solder a) before testing and b) after 3000 cycles -55°C to 125°C[12]

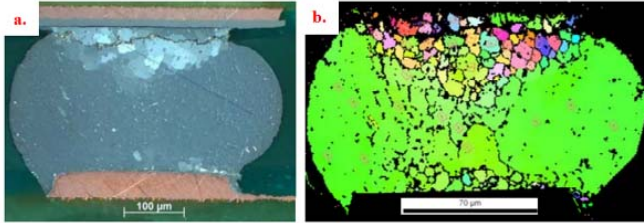
Figure 5: SAC305 after ATC shown with a)polarized light and b)EBSD mapping [13]

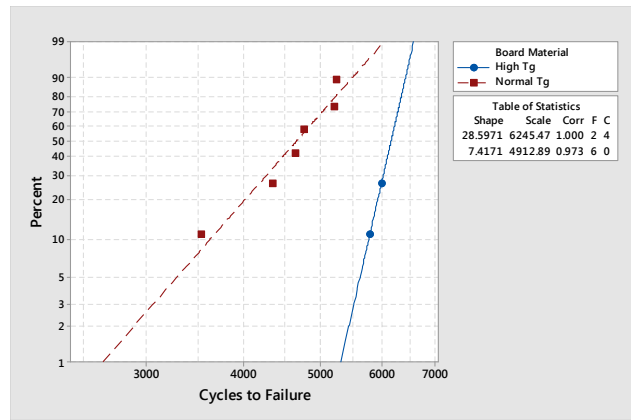
Table 7 summarizes the number of cycles to first failure of the QFP176s monitored during the 6010 cycles of the test. There are not enough failures at the end of 6010 cycles to plot failure distribution charts for each alloy. Only SAC305 experienced failures when built on High T_g (170°C) board material and those occurred towards the end of the test. Figure 10 shows the distribution of failures of solder joints built on High T_g boards compared with those built on Normal T_g boards. A two-parameter Weibull distribution is used.

Figure 10: Weibull plots of SAC305 QFP solder joints after 6010 Cycles 0-100°C, High to Normal T_g boards

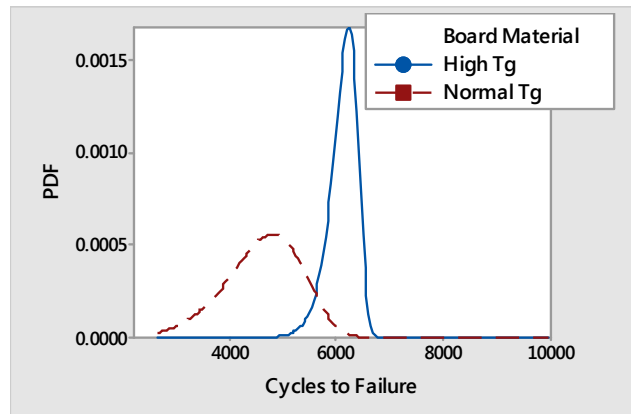
The shape parameter determines the shape of the probability distribution and can be viewed by plotting the probability density function (PDF). At values between 3 and 4, the shape parameter approximates a normal distribution. Shape parameter values higher than 4, as shown in Figure 11 results in a near-normal distribution with a left tail. The scale parameter (or slope on the Weibull distribution) described the range of the distribution, or the rate of at which the failure rate increases. It can be seen that the High T_g boards are expected to survive much longer than those built with Normal T_g when using SAC305 as the solder paste.

Figure 11: PDF of SAC305 QFP solder joints after 6010 Cycles 0-100°C, High to Normal T_g boards

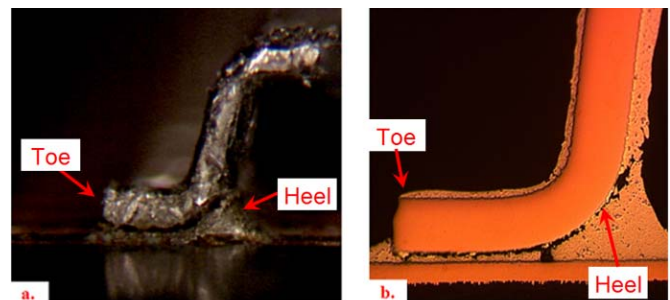
Figure 12 shows the failure occurred as a result of fracture initiating in the bulk solder and propagating along the lead side IMC layer. This is further illustrated in Figure 13 which shows the fracture surface of a similar solder joint made up of SAC305 on High T_g board material. The area highlighted in red shows the crack initiation. The area highlighted in green illustrates the point at which the fracture moves along the IMC layer. Within the green area, EDX scans were taken of area 1, which was shown to be pure Sn indicating bulk solder and area 2: which was shown to be Cu_6Sn_5 indicating the IMC layer. Finally, the area highlighted in blue shows a ductile fracture, which likely occurred as a result of overload on the remaining area.

Figure 12: QFP fracture of SAC305 on High T_g board a) optically and b) cross section

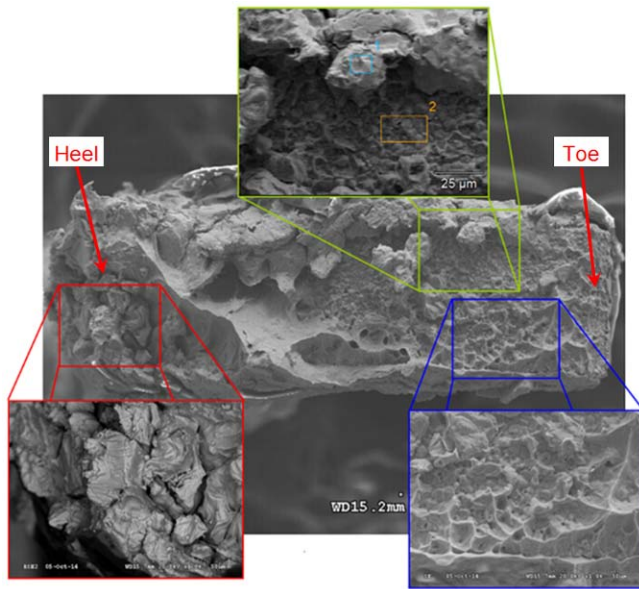
Figure 13: Fracture surface of QFP solder joint with SAC305 on High T_g board after 6010 cycles

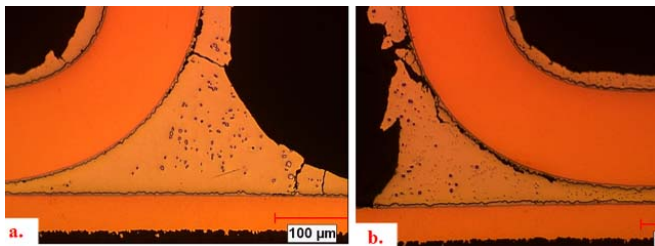
Figure 14 shows that fractures had initiated in solder joints formed with the other three alloys on high T_g board material, but by 6010 cycles had not yet propagated far enough into the solder joint to cause an electrical failure. It is expected that these solder joints would ultimately fail in the same manner as shown in Figure 12 and Figure 13 if the testing had continued.

Figure 14: Fracture initiation in QFP a) Sunflower b) Senju M42 after 6010 cycles

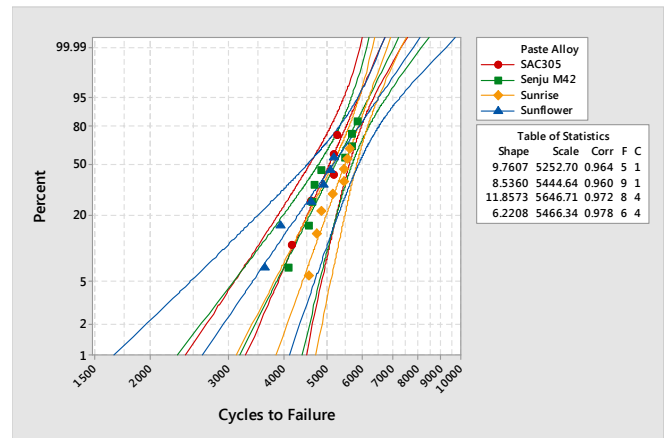
Figure 15 illustrates that there is no significant difference in the reliability performance of the solder joints formed using paste of the four alloys on Normal T_g boards. All BGA failures were found to result from board failures, specifically via cracks within the laminate material. The probability distributions for each alloy in this test exhibit similar shape and scale parameters, which is to be expected since all failures are characteristics of the board material and construction, rather than the solder alloy.

Figure 15: Weibull plots of BGA solder joints on Normal T_g boards after 6010 Cycles 0 to 100°C cycles

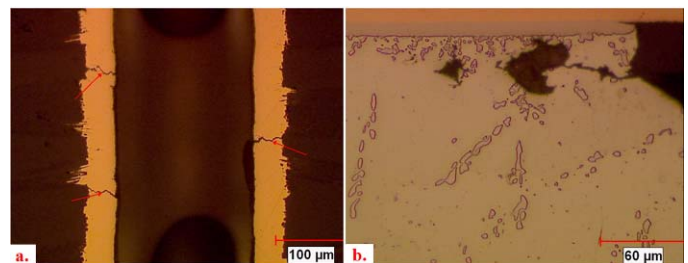
Figure 16 illustrates a) a typical via barrel failure and b) a bulk solder fracture – although incomplete failure – near the component side IMC.

Figure 16: BGA failures after 0 to 100°C ATC a) failure in board material by via plating crack and b) partial failure through bulk solder (SAC305) near component side IMC

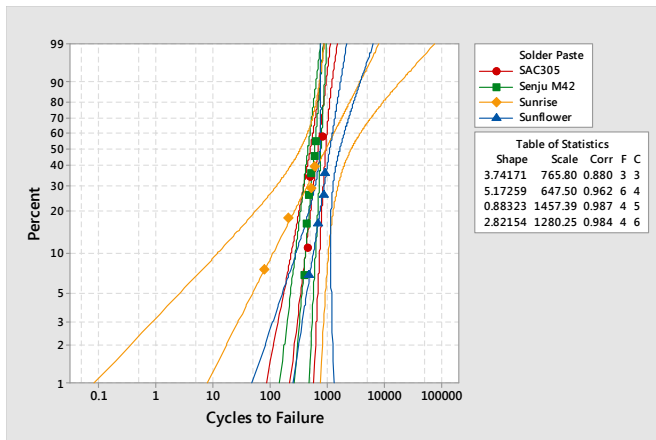
Figure 17 and Figure 18 show probability distribution plots and the probability density functions of the four alloys on High T_g board materials respectively. Sunrise showed some early fails, resulting in a different shape of the PDF. Figure 19 shows probability distribution plots of the four alloys on Normal T_g board materials respectively. In all cases, the distribution of failures occurred within overlapping confidence intervals; there is insufficient data to distinguish between the alloys after 1000 cycles of testing on Normal T_g boards.

Figure 17: Weibull plots of QFP failures on High T_g boards after 1000 cycles -55 -125°C

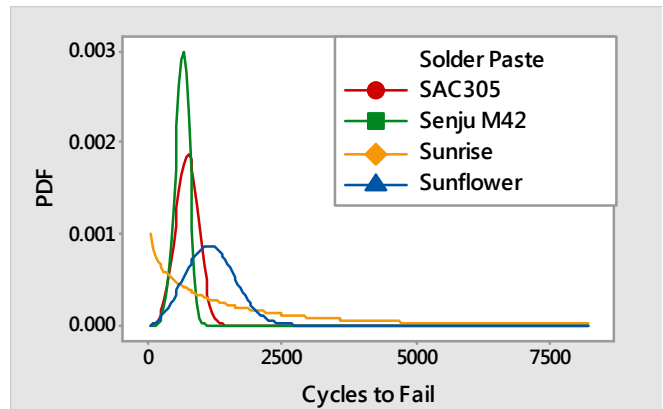
Figure 18: Probability Density Function for QFP failures on High T_g boards after 1000 cycles -55 -125°C

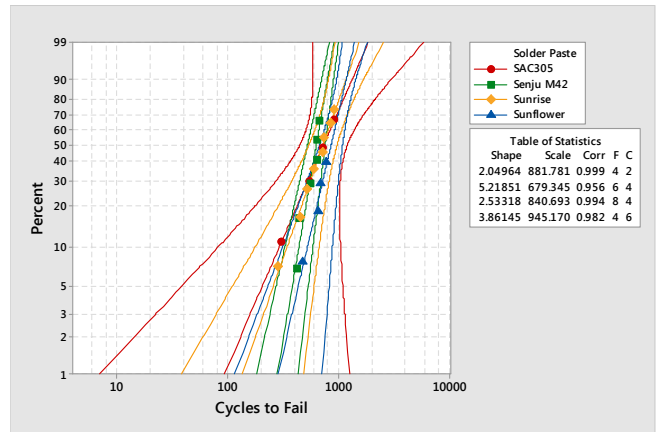
Figure 19: Weibull plots of QFP failures on Normal T_g boards after 1000 Cycles -55-125°C

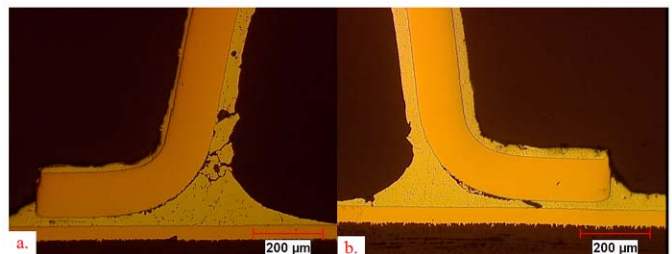
Just as in the 0 to 100°C cycling test, all QFPs experienced solder fracture initiating in the bulk solder and propagating along the lead side IMC (Figure 20). These however did not result in complete fracture, and would not account for the electrical failure. Further testing, by probing various test points in the test vehicle, determined that the likely cause of electrical failure was the copper trace separating from the board material. Copper trace fractures result in electrical open circuits.

Figure 20: QFP176 fractures in a) Sunflower and b) Senju M42 after 1000 cycles Harsh testing

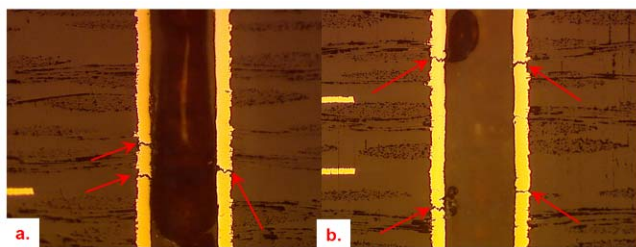
The BGA components that underwent harsh thermal cycling experienced many failures (Table 10). Upon cross sectional failure analysis however, these failures were found to be the result of board damage, as in the 0-100°C test, specifically

via cracks within the laminate material (Figure 21). While there are enough data points to plot probability distributions, this did not provide a means of distinguishing between alloys.

Figure 21: BGA failures after -55 to 125°C ATC failures in board material by via plating crack in boards built with Sunrise and b) boards built with Sunflower

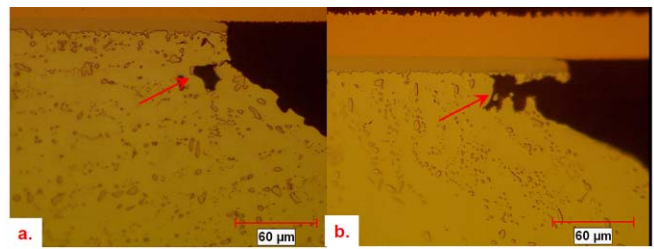
Further examination of the solder joints revealed some crack initiation in the solder joints towards the component side of the BGA solder joint. These crack initiation sites (

Figure 22) were less significant than the damage observed after 6010 cycles of 0-100°C thermal cycling and would not account for a failure reading. Electrical failures, just as in the case of 0-100°C thermal cycling, occurred as a result of via cracks in the board material (Figure 21). A probability plot comparing all failures on the two different board materials (Figure 23) illustrates that the board material was a more significant distinguishing factor than the various solder alloys.

Figure 22: BGA solder crack initiation after -55 to 125°C ATC in solder joints formed with SAC305 solder balls and a) Sunflower and b) Sunrise

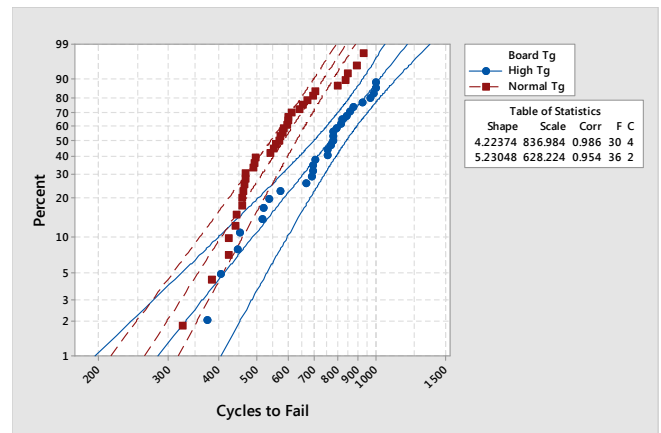
Figure 23: Weibull plots of BGA solder joints after 1000 Cycles -55 to 125C cycles comparing two board materials

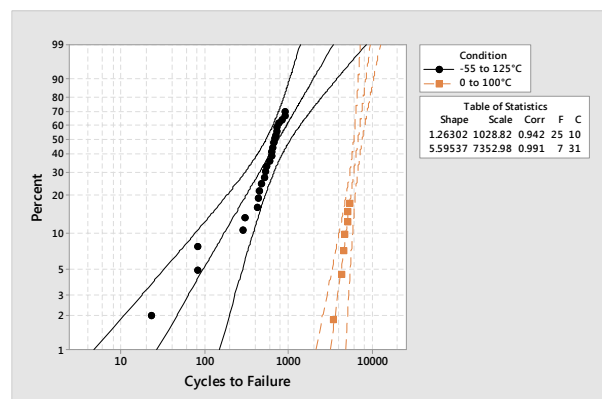
QFP solder joint failures on Normal T$_g$ board material was used to compare the two test conditions, 0-100°C for 6010 cycles and -55 to 125°C for 1000 cycles. The Harsh environment test (-55 to 125°C) produced many failures over the 1000 cycles, including a few early failures. This resulted in a Weibull distribution with a shape parameter of 1.26, a PDF with a right tail. The 0-100°C was less severe and therefore resulted in fewer failures and no early failures. The shape parameter of 5.59 indicates that the failure rate increases over time.

Figure 24: Weibull plot for QFP solder joints on Normal Tg boards comparing two test conditions

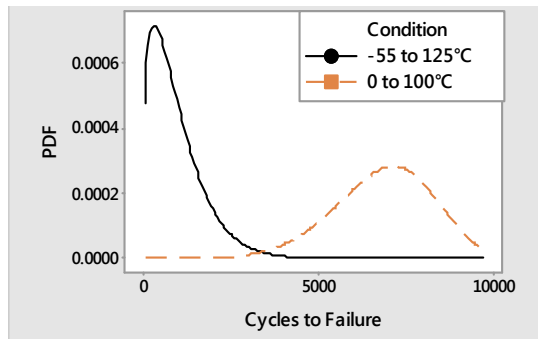
Figure 25: Probability Density Function for QFP failures on Normal Tg boards comparing two test conditions

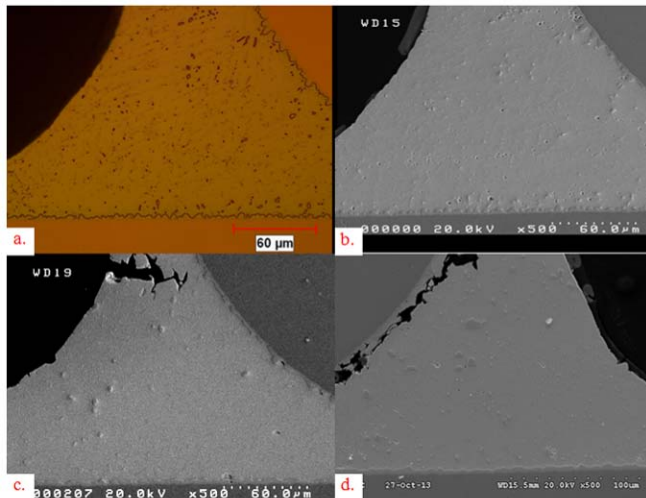
SAC305, before thermal cycling (Figure 26a and 73b) appears as small dendrite arms surrounded by small Ag_3Sn and Cu_6Sn_5 particles. After thermal cycling from 0 to 100°C for 3148 and 6010 cycles (Figure 26c and 73d respectively) the intermetallic particles coalesced into fewer, larger particles. Senju M42 behaved in the same manner. In both cases, the bulk of the microstructural transition occurred between 0 and 3148 cycles, with little change between 3148 and 6010 cycles. With 3% Bi in Senju M42, there does not appear to be any significant Bi precipitation from the solid solution (Figure 27).

Figure 26: SAC305 at Time 0 a) optically and b) SEM image and after b) 3148 cycles and d) 6010 cycles of 0-100°C ATC

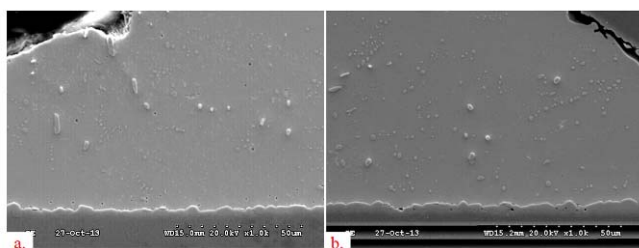
Figure 27: Senju M42 at 1000x after a) 3148 cycles and b) 6010 cycles

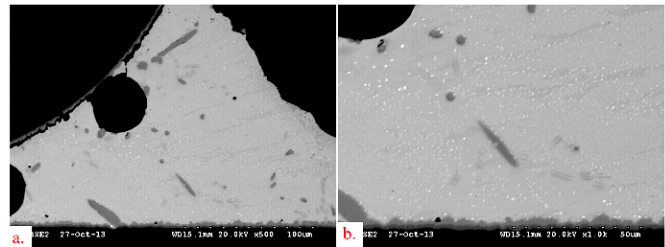
Sunrise and Sunflower solder paste alloys, which both contain 7wt% Bi, showed a significant amount of Bi precipitation after ATC. In both cases large, uneven particles of Bi were present upon solidification, as seen in Chapter 2. After ATC, Sunrise showed many, very small particles precipitated throughout the bulk, evenly dispersed from the βSn grains (Figure 28). Sunflower also exhibited some Bi accumulation along the grain boundaries (Figure 29). In both cases, there did not appear to be any significant accumulation of Bi along the interface with the interfacial IMC layer.

**Figure 28:** Sunrise after 6010 cycles 0-100°C at a) 500x and b) 1000x

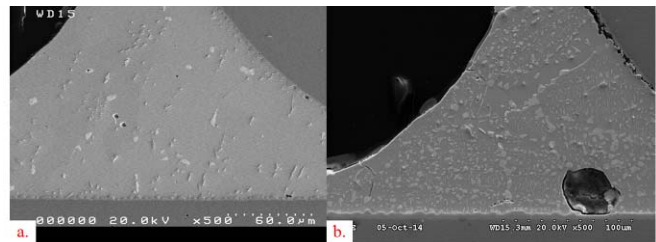
Figure 29: Sunflower at a) Time 0 and b) after 6010 cycles 0-100°C at 500x

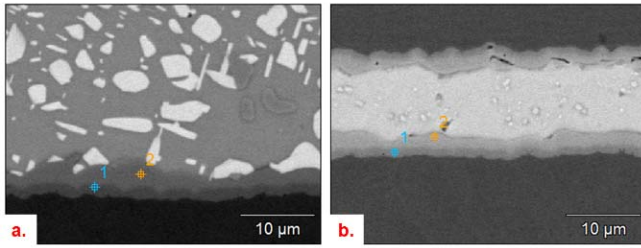
Figure 30: IMC layers formed on QFP176 solder joints between the board side Cu layer and solder paste a) sunrise and b) SAC305 after 438 cycles of Harsh thermal cycling. Location 1 shows the Cu_3Sn layer, location 2 shows the Cu_6Sn_5 layer

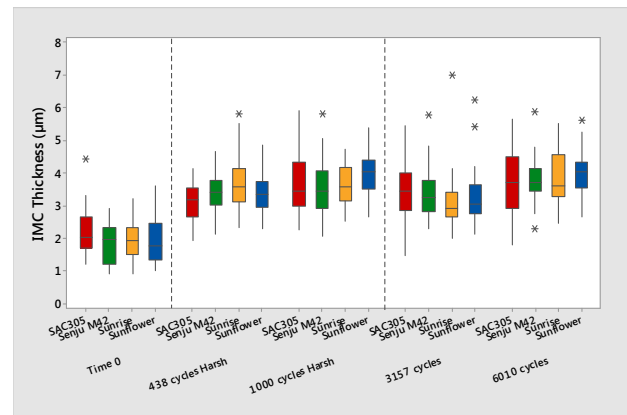
Figure 31 provides a comparison of the overall IMC thickness at the various test intervals; Figure 32 provides a comparison of the Cu_3Sn layer within the IMC at various test intervals. Table 11 and

**Figure 31:** IMC growth at the board side of QFP during thermal cycling

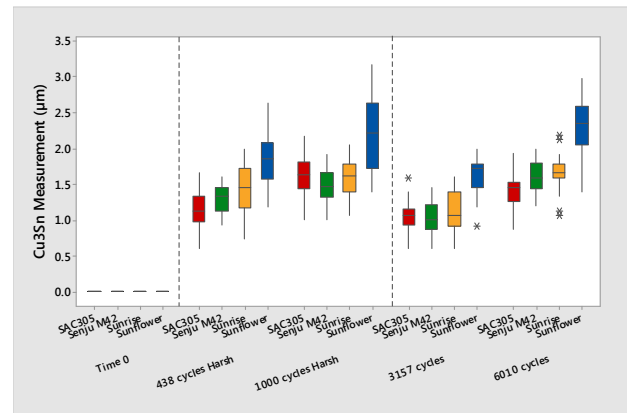
The result of ANOVA testing, indicated in Table 13: ANOVA test equal variance and means, show that while the total IMC thickness increased relatively consistently among the four alloys, the increase in the thickness of the Cu_3Sn layer was different in at least one alloy. Figure 32 clearly shows that Sunflower exhibited a significantly thicker Cu_3Sn layer after Time 0 in both test conditions.

Figure 32: Cu_3Sn (portion of IMC) growth at board side of QFP during thermal cycling
